King County Wagners Bridge

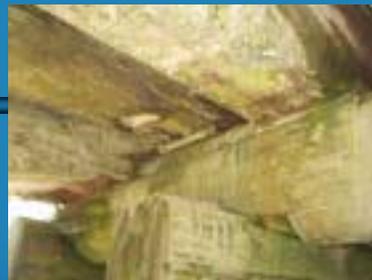
Rot at Log Crib Abutment

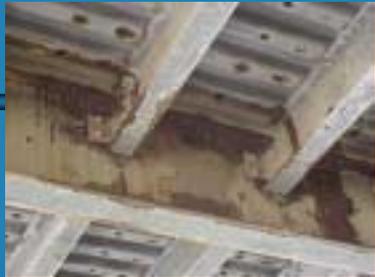
Failing Paint System

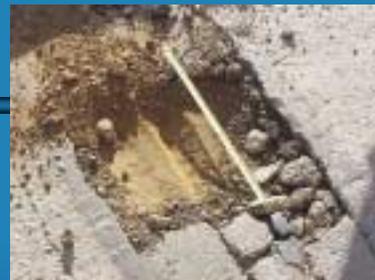
Damage at Deck Joint

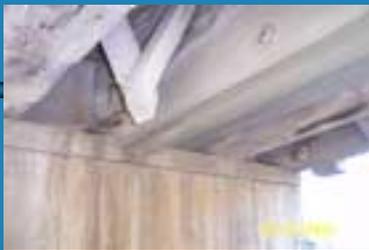
View of Deteriorated Timbers

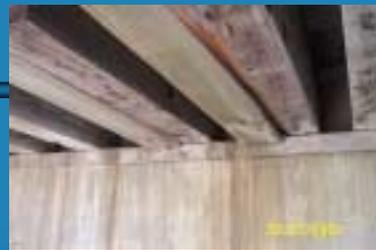
View of Timber Repair

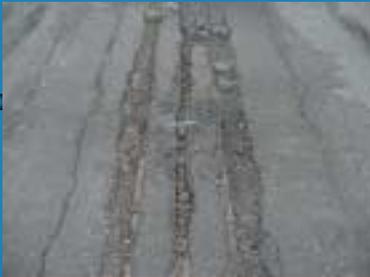
Asphalt Overlay Condition

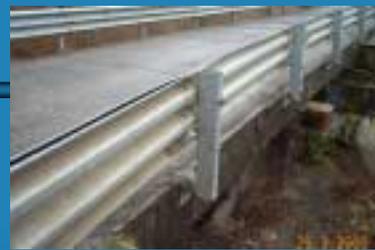
Substandard Rail

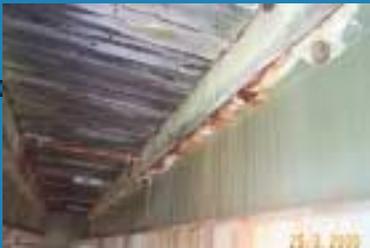
Deterioration and Loose Bolts

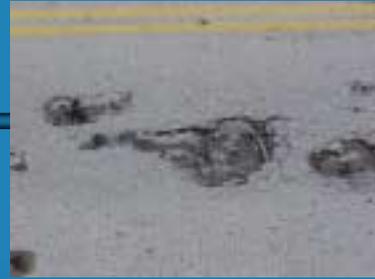
Potholes in Deck with Exposed Rebar

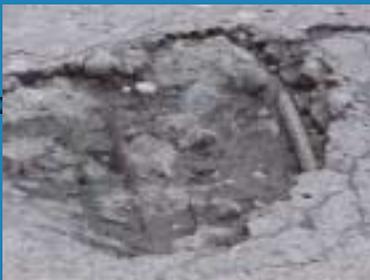
Close-up of Deck Spall

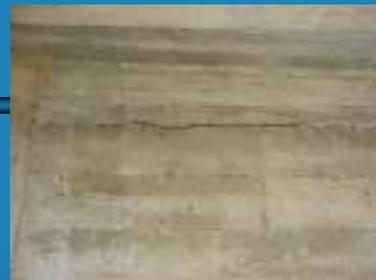
Typical Longitudinal Cracking

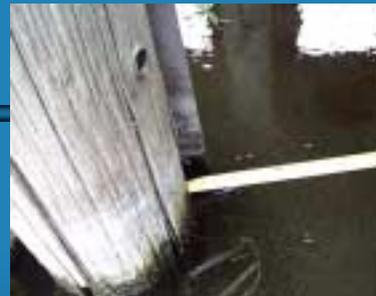
Pile Deterioration

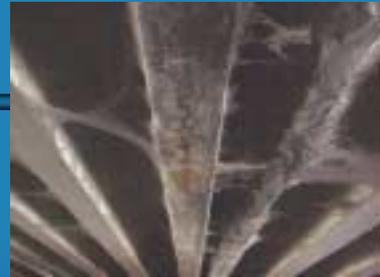
View of Web Cracking

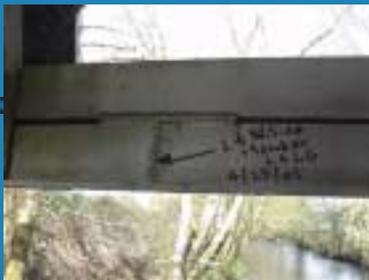
Cracked Weld

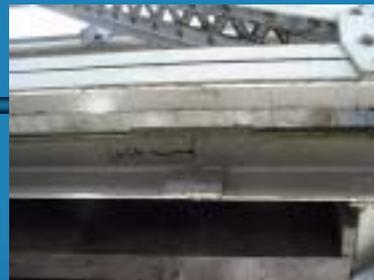
Cracked Weld

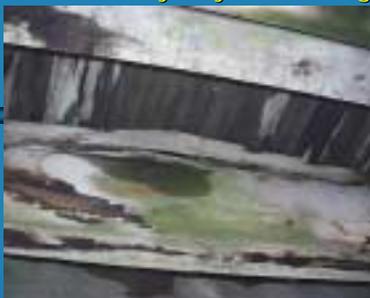
Timber Stringer Deterioration

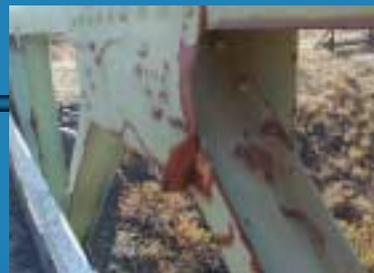
Typical Traffic Damage

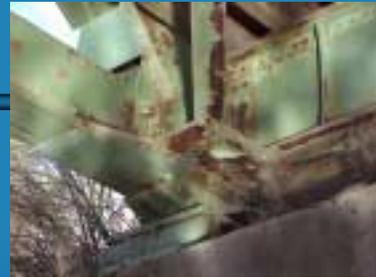
Typical Paint Deterioration

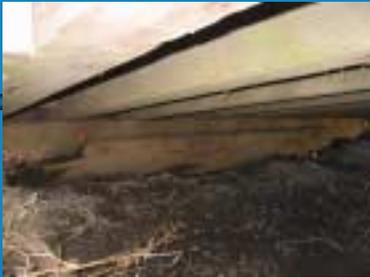
Deteriorated Mud Sill

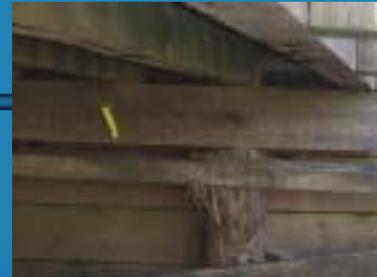
Deteriorated Pile Cap and High Water Evidence

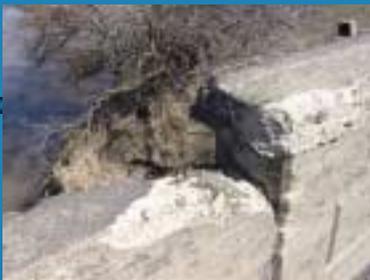
Barrier Damage

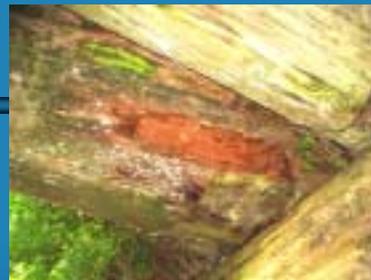
Rot at Bearing

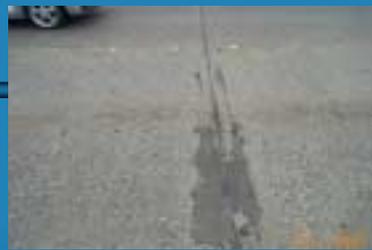
Spall Repair Over Floorbeam

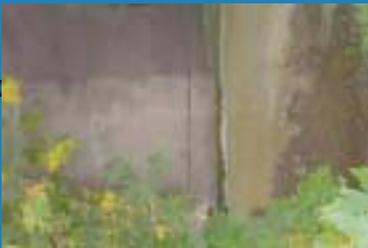
View of Exposed Rebar
